Original Research Article

# Adaptive Reuse of Historical Churches: An Analysis of Eight Case Studies

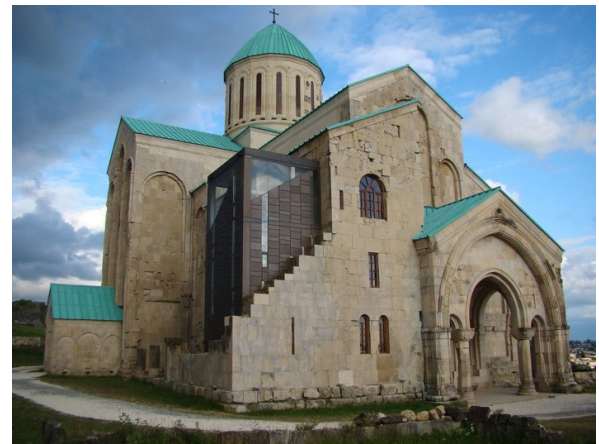
Constructed in the year 1003, Bagrati Cathedral stands as a significant cultural edifice within the political and architectural history of Georgia. Devastated by an explosion in 1691, the cathedral was registered in its ruined state on the UNESCO World Heritage List in 1994. The reconstruction of Bagrati Cathedral, completed in September 2012, has drawn the focused attention of Georgian politicians, authorities of the Georgian Orthodox Church, and architectural historians. Some contend that the reconstruction of Bagrati Cathedral was part of the political agenda of Mikheil Saakashvili, the then-president of Georgia, and acted contrary to the objectives of architectural historians and the academic principles of restoration and conservation. As a result, the reconstructed Bagrati now faces the risk of being removed from the World Heritage List. According to the World Heritage Committee's report, "Bagrati Cathedral has been altered to such an extent that its authenticity has been irreversibly compromised." Contrary to the recommendations of ICOMOS, the remaining original stone blocks were not reused, and new structural sections made of reinforced concrete were irreversibly embedded into the historical fabric (Brumann, 2017) (Fig. 5). The reconstruction of Bagrati has implications for the future of conservation and restoration practices in Georgia.

Fig. 5. Bagrati Cathedral. Source: [www.flickr.com](http://www.flickr.com).

The overall added volume to Kolumba Church is constructed of gray bricks except for the glass windows. In Bagrati Cathedral, the overall volume is made of metal and glass, which has been criticized for the irreversible nature of the construction method. Comparing these two structures clearly shows how the choice of materials significantly affects the outcome.

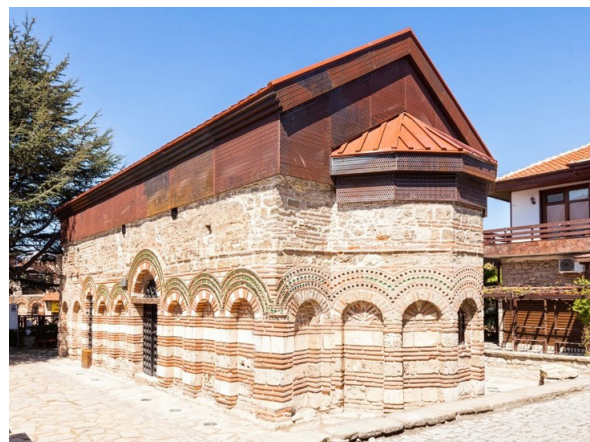
local museum. The most significant issues were the considerable demolition of the building's height and the unstable, jagged walls. Nevertheless, the church retains the characteristics of a vital urban structural element. The intervention and reclamation of its functional significance restore the building's bold role in the city's composition and character. All original elements were carefully protected, and harmonious interventions were carried out. Contemporary tools and techniques were employed to recreate the spatial features of the church. Only elements with undeniable evidence were restored, avoiding any hypothetical restorations. Perforated corten steel sheets were used to articulate the building's original structure, both internally and externally. These materials harmonize well with the church's color and are recognized as contemporary. The sequence of brick and stone layers of varying sizes in the original building's façade has been replicated by creating holes in the steel sheets. The contact of new materials with the original structure is minimal, and all interventions are reversible (Moazen & Sad Berenji, 2024) (Fig. 6).

Fig. 6. Saint Paraskeva Church. Source: www.archdaily.com.

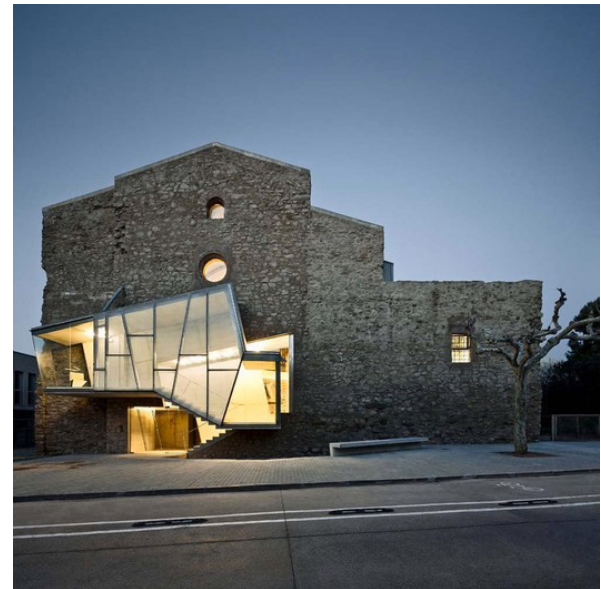
Another challenge was maintaining the unity and originality of the dimensions of the nave after the construction of new annexes and volumes for the needs and needs of the church, including stairs to access the upper floor, toilets, and equipment room. Complementary structures were strategically placed to stand apart, some outside the edifice and others inside, all arranged to maintain the spatial coherence and architectural integrity of the church. This careful placement ensured that the broad view of the nave and the unique atmosphere of the main church remained unobstructed. In addition to providing access to the upper floors of the church, the building's stairway and ramp set defined a circular path throughout the building that resembled a museum. This circular path allows the whole church to be viewed from different fronts. By adding new values, the intervention to preserve the historical heritage of the building has enhanced it and given the old monastery a contemporary and unique look (Moazen & Sad Berenji, 2024). Clouses, the architect of the new parts, says: Instead of rebuilding, we have strengthened the existing condition of the old texture and added new elements that are different from the old textures. The reinforcements were done without removing the processes of decay and decay that have damaged the building. The materials used in the renovation are mainly glass and steel, which perfectly harmonize with the rough stone (Fig. 8).

A new entrance has been defined for this building. According to some, the issue of linking the new to the old has found an extreme solution here in the creation of new volumes. These volumes are placed on the collapsing spaces of the monastery, seemingly suspended, but in fact, resting on the

remains of ancient masonry walls and supported by large concrete beams (Fiorani, 2017).

Fig. 8. Saint Francis Church. Source: [www.archdaily.com](http://www.archdaily.com).

Two structures in this study feature appended entrance spaces. In Saint Francis Church, a combination of glass and metal forms an abstract volumetric facade. Studies suggest that restorations aimed at adaptive reuse and reconstruction of a historical building can employ glass elements as a means to enclose intermediary spaces (between columns, arcades, and vaults) or as part of an extension, usually abstract in form, to accommodate internal conditions and integrate new functions. The Saint Francis Monastery demonstrates the potential of glass in expansion structures, which can completely transform a historical building (ibid., 2018).

area before annexes). In the Church of Saint Francis in Spain, due to the large size of the church, it is possible to define different spaces and uses within it. Consequently, the building contains additions such as internal stairs for connecting different levels. Similarly, in the Kolumba Museum, wooden pathways have been defined to create an exhibition route for viewing archaeological remains, and floors have been added to increase the exhibition space. In the Dominican Museum, a metal structure has been added for the display and sale of books. Whereas in smaller extent buildings, most changes are limited to optimizing the conditions of collapsed roofs and walls, as seen in the churches of Vilanova or Banos.

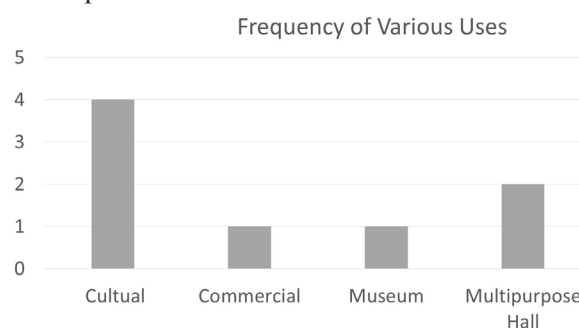
Determining a new use for historical buildings, especially churches, is one of the most contentious aspects of their adaptive reuse. Various studies emphasize the importance of public participation and considering their opinions alongside those of experts, rather than solely relying on investors' perspectives. This is because investors often prioritize economic profitability, while experts prioritize the preservation of authenticity and integrity (Ahn, 2007). Among the uses considered for these eight churches, as observable in Fig. 10, cultural uses are most prevalent, followed by multipurpose halls.

Given that the Kolumba Museum displays religious art, its use can also be considered under the cultural category. Moreover, multipurpose halls are often places for public gatherings and hosting events with cultural-social content. If these types of uses are also included

under the cultural category, then more than 87% of the defined uses for these buildings in the case studies of this research are cultural. Even bookstores while falling under the commercial category, have a cultural essence. Thus, it appears that uses with cultural roots have been deemed more appropriate for the adaptive reuse of the religious architecture of churches.

Fig. 10. Frequency of Uses in Adaptive Reuse of the 8 Churches Studied in This Research. Source: authors.
