## Original Research Article

# Adaptive Reuse of Historical Churches: An Analysis of Eight Case Studies

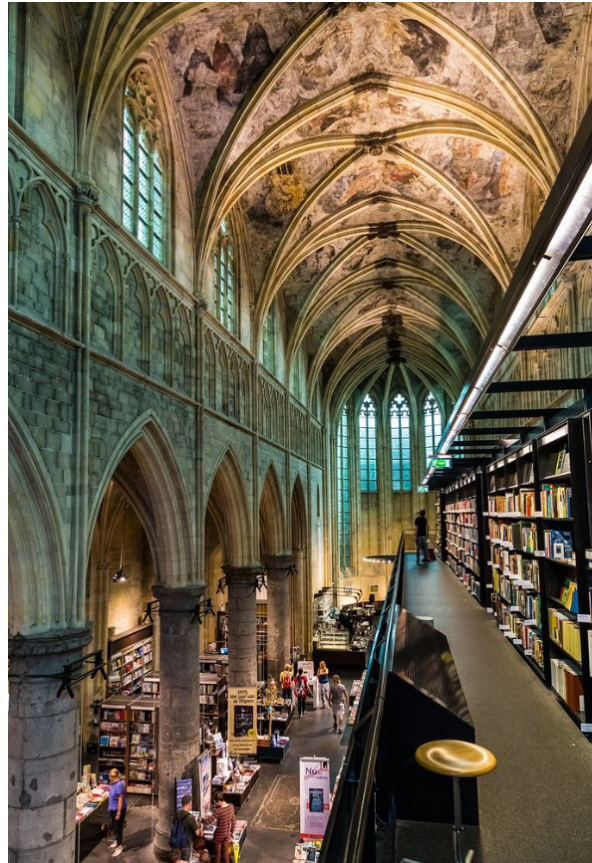
Fig. 1. Dominican Church. Source: [www.arcstreet.com](http://www.arcstreet.com).

The Dominican Church is a 13th-century Gothic church built in 1294 in the center of Maastricht from stone and served the local Dutch community for 500 years. In 1796, its ecclesiastical function ceased with Napoleon's invasion, and subsequent uses included bicycle storage, exhibition space, and a banquet hall. In 2006, the church found a new destiny when a bookstore was created inside it (Ciranna, 2017, Zargaran, 2017). This bookstore is one of the most beautiful in the world, housed in a perfectly preserved old church brimming with wall and ceiling paintings. Many believe that the "true power of reading" is revealed in the old church. External elements such as stained glass, wall paintings, arches, and the quality of light in the space have been preserved (Fig. 1). A "book tower" made of steel with two floors (400 square meters) was constructed to create an overhead view inside the church. In addition, a

very modern entrance made of weathering steel (Corten steel) was attached to the building, which appears old due to the material used (Mirabella Roberti, 2017). The project's success is thanks to the successful collaboration of public and private organizations (municipality, historical building care, project developer, and new user). This project won the Lensvelt Architectural Prize in 2007 in the Netherlands (Vellecco & Martone, 2021). There are differing opinions about the extent and manner of interventions in this work. Some believe that during this change of use, the original architectural structure has been preserved but now includes a contemporary addition that respects its religious and symbolic value and is also reversible. Others believe that the new metal mezzanines, structurally separate from the original structure, are visually discordant and severely weaken the spatial identity of the building. This structure occupies half of the main nave and one of the two side aisles, creating a denial of symmetry in the original structure. This process follows a postmodern trend and induces a kind of semantic detachment that aims to neutralize symbolic focus (Harney, 2017; Mirabella Roberti, 2017). Among the criticisms of this project is the change of use of the altar area into a bar, which some consider a mocking perspective (Fiorani et al., 2017, 355).

The Dominican Church has also defined a metallic entrance using Corten steel. Due to its inherent rust-like appearance, Corten steel conveys a sense of age and the passage of time, making it a suitable material for new additions to old buildings.

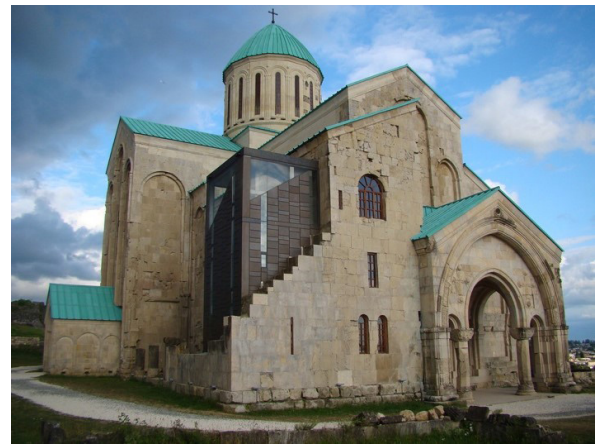
Fig. 5. Bagrati Cathedral. Source: [www.flickr.com](http://www.flickr.com).

Constructed in the year 1003, Bagrati Cathedral stands as a significant cultural edifice within the political and architectural history of Georgia. Devastated by an explosion in 1691, the cathedral was registered in its ruined state on the UNESCO World Heritage List in 1994. The reconstruction of Bagrati Cathedral, completed in September 2012, has drawn the focused attention of Georgian politicians, authorities of the Georgian Orthodox Church, and architectural historians. Some contend that the reconstruction of Bagrati Cathedral was part of the political agenda of Mikheil Saakashvili, the then-president of Georgia, and acted contrary to the objectives of architectural historians and the academic principles of restoration and conservation. As a result, the reconstructed Bagrati now faces the risk of being removed from the World Heritage List. According to the World Heritage Committee's report, "Bagrati Cathedral has been altered to such an extent that its authenticity has been irreversibly compromised." Contrary to the recommendations of ICOMOS, the remaining original stone blocks were not reused, and new structural sections made of reinforced concrete were irreversibly embedded into the historical fabric (Brumann, 2017) (Fig. 5). The reconstruction of Bagrati has implications for the future of conservation and restoration practices in Georgia.

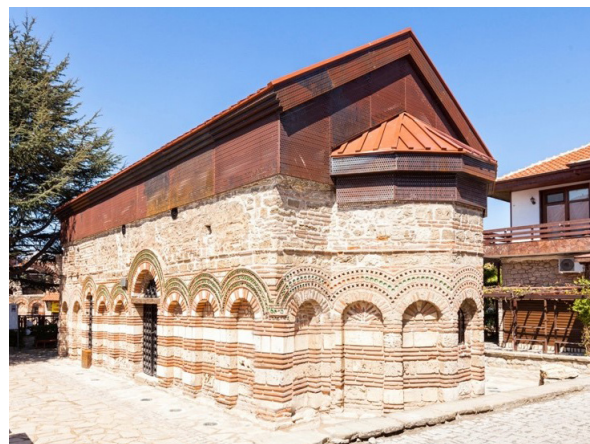
Fig. 6. Saint Paraskeva Church. Source: [www.archdaily.com](http://www.archdaily.com).

local museum. The most significant issues were the considerable demolition of the building's height and the unstable, jagged walls. Nevertheless, the church retains the characteristics of a vital urban structural element. The intervention and reclamation of its functional significance restore the building's bold role in the city's composition and character. All original elements were carefully protected, and harmonious interventions were carried out. Contemporary tools and techniques were employed to recreate the spatial features of the church. Only elements with undeniable evidence were restored, avoiding any hypothetical restorations. Perforated corten steel sheets were used to articulate the building's original structure, both internally and externally. These materials harmonize well with the church's color and are recognized as contemporary. The sequence of brick and stone layers of varying sizes in the original building's façade has been replicated by creating holes in the steel sheets. The contact of new materials with the original structure is minimal, and all interventions are reversible (Moazen & Sad Berenji, 2024) (Fig. 6).

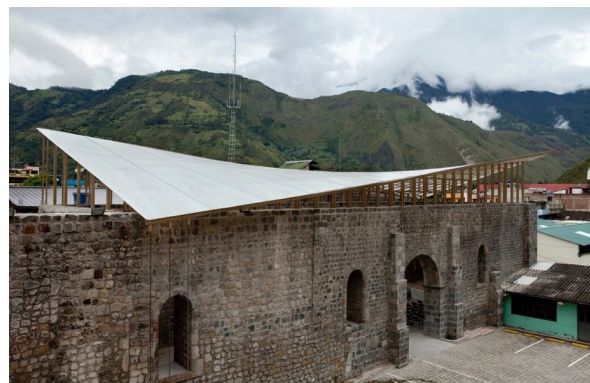
Fig. 7. Baños Church. Source: [www.archdaily.com](http://www.archdaily.com).

- Protecting and reinforcing the existing structure (internal walls and remaining roof materials), ensuring ventilation and natural light (Moazen & Sad Berenji, 2024). The old church's walls were confined by a series of adjacent buildings, which diminished the significance of the existing structure. The dynamism of the new roof, in contrast to the church's static environment, revalues the hidden virtues of the old church. The proposed materials possess the necessary characteristics to demonstrate the design's difference from the original structure: a metal framework and transparent polycarbonate (Fig. 7).

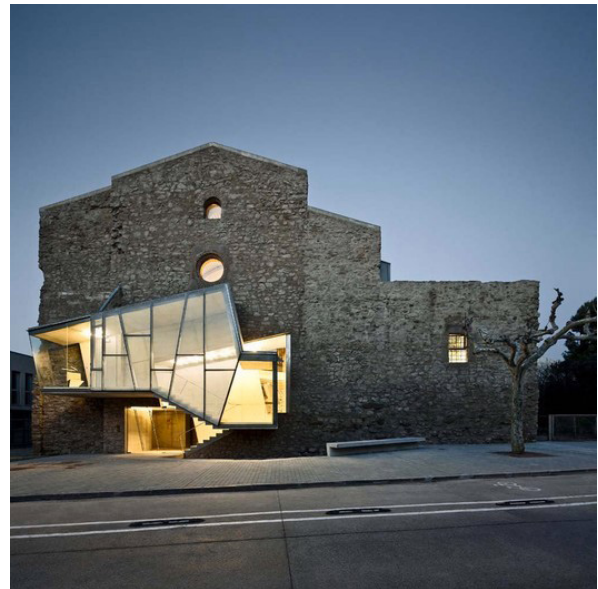
Fig. 8. Saint Francis Church. Source: [www.archdaily.com](http://www.archdaily.com).

Another challenge was maintaining the unity and originality of the dimensions of the nave after the construction of new annexes and volumes for the needs and needs of the church, including stairs to access the upper floor, toilets, and equipment room. Complementary structures were strategically placed to stand apart, some outside the edifice and others inside, all arranged to maintain the spatial coherence and architectural integrity of the church. This careful placement ensured that the broad view of the nave and the unique atmosphere of the main church remained unobstructed. In addition to providing access to the upper floors of the church, the building's stairway and ramp set defined a circular path throughout the building that resembled a museum. This circular path allows the whole church to be viewed from different fronts. By adding new values, the intervention to preserve the historical heritage of the building has enhanced it and given the old monastery a contemporary and unique look (Moazen & Sad Berenji, 2024). Clouses, the architect of the new parts, says: Instead of rebuilding, we have strengthened the existing condition of the old texture and added new elements that are different from the old textures. The reinforcements were done without removing the processes of decay and decay that have damaged the building. The materials used in the renovation are mainly glass and steel, which perfectly harmonize with the rough stone (Fig. 8).

A new entrance has been defined for this building. According to some, the issue of linking the new to the old has found an extreme solution here in the creation of new volumes. These volumes are placed on the collapsing spaces of the monastery, seemingly suspended, but in fact, resting on the

remains of ancient masonry walls and supported by large concrete beams (Fiorani, 2017).

Two structures in this study feature appended entrance spaces. In Saint Francis Church, a combination of glass and metal forms an abstract volumetric facade. Studies suggest that restorations aimed at adaptive reuse and reconstruction of a historical building can employ glass elements as a means to enclose intermediary spaces (between columns, arcades, and vaults) or as part of an extension, usually abstract in form, to accommodate internal conditions and integrate new functions. The Saint Francis Monastery demonstrates the potential of glass in expansion structures, which can completely transform a historical building (ibid., 2018).
