## Original Research Article

# Adaptive Reuse of Historical Churches: An Analysis of Eight Case Studies

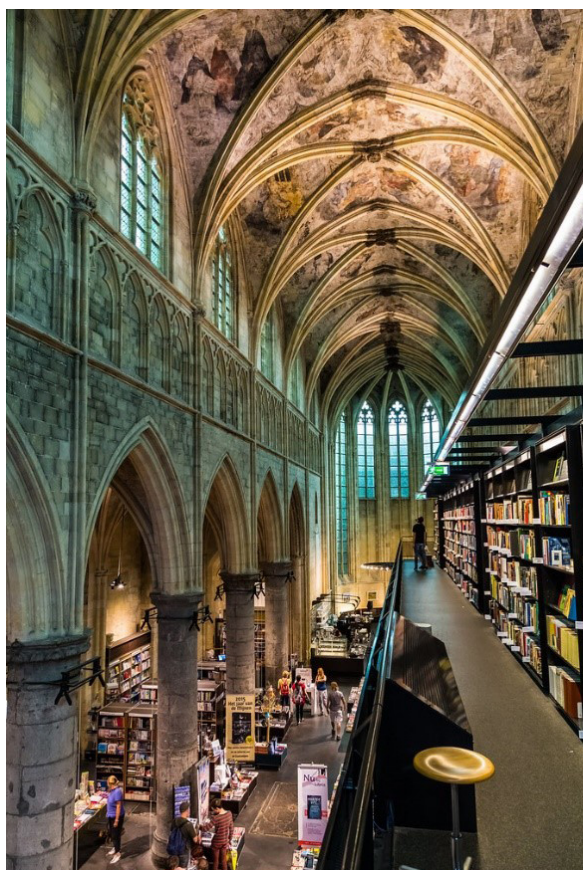
Fig. 1. Dominican Church. Source: www.arcstreet.com.

The Dominican Church is a 13th-century Gothic church built in 1294 in the center of Maastricht from stone and served the local Dutch community for 500 years. In 1796, its ecclesiastical function ceased with Napoleon's invasion, and subsequent uses included bicycle storage, exhibition space, and a banquet hall. In 2006, the church found a new destiny when a bookstore was created inside it (Ciranna, 2017, Zargarán, 2017). This bookstore is one of the most beautiful in the world, housed in a perfectly preserved old church brimming with wall and ceiling paintings. Many believe that the "true power of reading" is revealed in the old church. External elements such as stained glass, wall paintings, arches, and the quality of light in the space have been preserved (Fig. 1). A "book tower" made of steel with two floors (400 square meters) was constructed to create an overhead view inside the church. In addition, a

very modern entrance made of weathering steel (Corten steel) was attached to the building, which appears old due to the material used (Mirabella Roberti, 2017). The project's success is thanks to the successful collaboration of public and private organizations (municipality, historical building care, project developer, and new user). This project won the Lensvelt Architectural Prize in 2007 in the Netherlands (Vellecco & Martone, 2021). There are differing opinions about the extent and manner of interventions in this work. Some believe that during this change of use, the original architectural structure has been preserved but now includes a contemporary addition that respects its religious and symbolic value and is also reversible. Others believe that the new metal mezzanines, structurally separate from the original structure, are visually discordant and severely weaken the spatial identity of the building. This structure occupies half of the main nave and one of the two side aisles, creating a denial of symmetry in the original structure. This process follows a postmodern trend and induces a kind of semantic detachment that aims to neutralize symbolic focus (Harney, 2017; Mirabella Roberti, 2017). Among the criticisms of this project is the change of use of the altar area into a bar, which some consider a mocking perspective (Fiorani et al., 2017, 355).

Among the case studies discussed in this article, the Dominican Church had the least need for restoration actions and did not have many collapsed roofs or walls. However, it has the most internal additions for functional adaptation. The added volumes to the historical structure of the Bagrati Cathedral are so significant that it has become a candidate for endangered status and

The Dominican Church has also defined a metallic entrance using Corten steel. Due to its inherent rust-like appearance, Corten steel conveys a sense of age and the passage of time, making it a suitable material for new additions to old buildings.

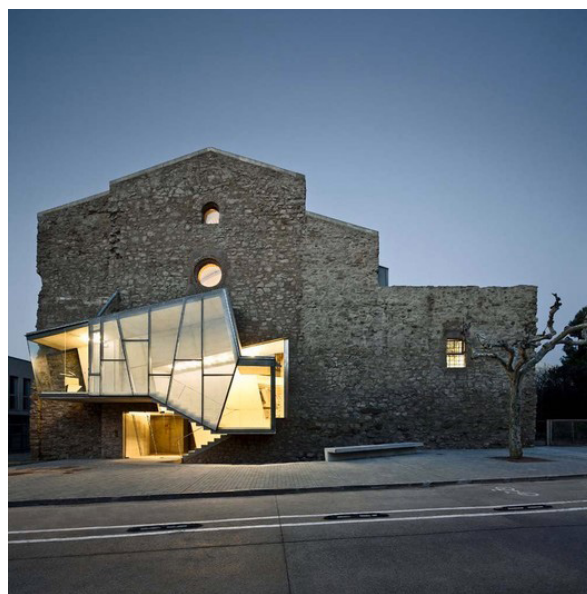
Fig. 8. Saint Francis Church. Source: www.archdaily.com.

Another challenge was maintaining the unity and originality of the dimensions of the nave after the construction of new annexes and volumes for the needs and needs of the church, including stairs to access the upper floor, toilets, and equipment room. Complementary structures were strategically placed to stand apart, some outside the edifice and others inside, all arranged to maintain the spatial coherence and architectural integrity of the church. This careful placement ensured that the broad view of the nave and the unique atmosphere of the main church remained unobstructed. In addition to providing access to the upper floors of the church, the building's stairway and ramp set defined a circular path throughout the building that resembled a museum. This circular path allows the whole church to be viewed from different fronts. By adding new values, the intervention to preserve the historical heritage of the building has enhanced it and given the old monastery a contemporary and unique look (Moazen & Sad Berenji, 2024). Clouses, the architect of the new parts, says: Instead of rebuilding, we have strengthened the existing condition of the old texture and added new elements that are different from the old textures. The reinforcements were done without removing the processes of decay and decay that have damaged the building. The materials used in the renovation are mainly glass and steel, which perfectly harmonize with the rough stone (Fig. 8).

A new entrance has been defined for this building. According to some, the issue of linking the new to the old has found an extreme solution here in the creation of new volumes. These volumes are placed on the collapsing spaces of the monastery, seemingly suspended, but in fact, resting on the

remains of ancient masonry walls and supported by large concrete beams (Fiorani, 2017).

Two structures in this study feature appended entrance spaces. In Saint Francis Church, a combination of glass and metal forms an abstract volumetric facade. Studies suggest that restorations aimed at adaptive reuse and reconstruction of a historical building can employ glass elements as a means to enclose intermediary spaces (between columns, arcades, and vaults) or as part of an extension, usually abstract in form, to accommodate internal conditions and integrate new functions. The Saint Francis Monastery demonstrates the potential of glass in expansion structures, which can completely transform a historical building (ibid., 2018).
