Original Research Article

Adaptive Reuse of Historical Churches: An Analysis of Eight Case Studies

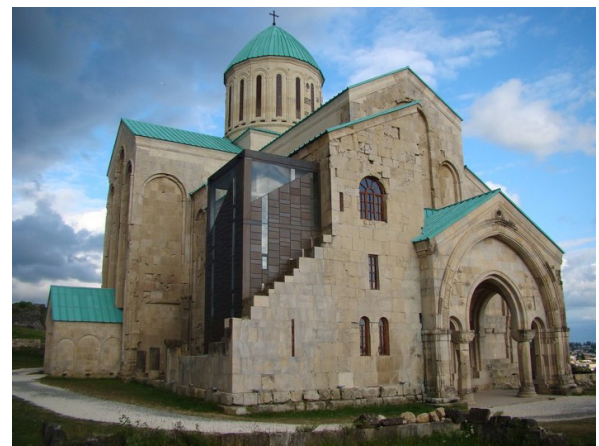
Fig. 5. Bagrati Cathedral. Source: www.flickr.com.

Constructed in the year 1003, Bagrati Cathedral stands as a significant cultural edifice within the political and architectural history of Georgia. Devastated by an explosion in 1691, the cathedral was registered in its ruined state on the UNESCO World Heritage List in 1994. The reconstruction of Bagrati Cathedral, completed in September 2012, has drawn the focused attention of Georgian politicians, authorities of the Georgian Orthodox Church, and architectural historians. Some contend that the reconstruction of Bagrati Cathedral was part of the political agenda of Mikheil Saakashvili, the then-president of Georgia, and acted contrary to the objectives of architectural historians and the academic principles of restoration and conservation. As a result, the reconstructed Bagrati now faces the risk of being removed from the World Heritage List. According to the World Heritage Committee's report, "Bagrati Cathedral has been altered to such an extent that its authenticity has been irreversibly compromised." Contrary to the recommendations of ICOMOS, the remaining original stone blocks were not reused, and new structural sections made of reinforced concrete were irreversibly embedded into the historical fabric (Brumann, 2017) (Fig. 5). The reconstruction of Bagrati has implications for the future of conservation and restoration practices in Georgia.

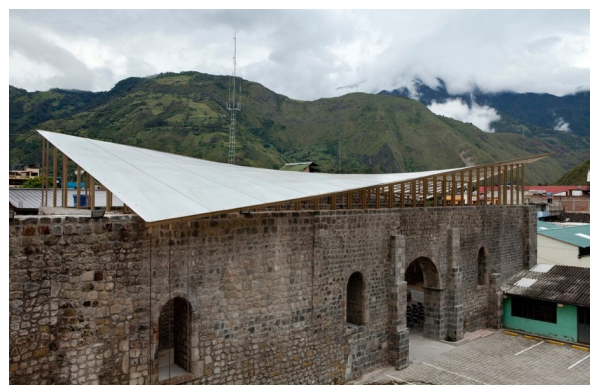
Fig. 7. Baños Church. Source: www.archdaily.com.

- Protecting and reinforcing the existing structure (internal walls and remaining roof materials), ensuring ventilation and natural light (Moazen & Sad Berenji, 2024). The old church's walls were confined by a series of adjacent buildings, which diminished the significance of the existing structure. The dynamism of the new roof, in contrast to the church's static environment, revalues the hidden virtues of the old church. The proposed materials possess the necessary characteristics to demonstrate the design's difference from the original structure: a metal framework and transparent polycarbonate (Fig. 7).
